Manhole Inspection Summary

Manhole # S13II_009MH

Location Address: **2903 HERBERT ST**

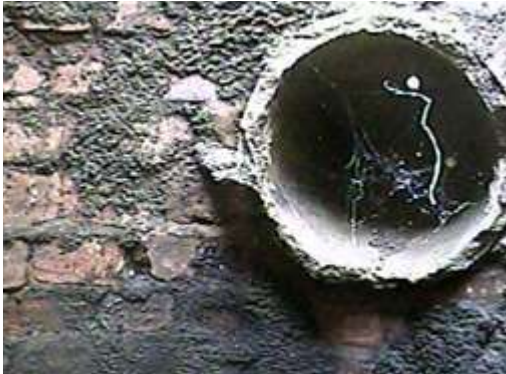
UNKNOWN

POSSIBLE THROUGHPIPE # 2

POSSIBLE PREVIOUS THROUGHPIPE #1

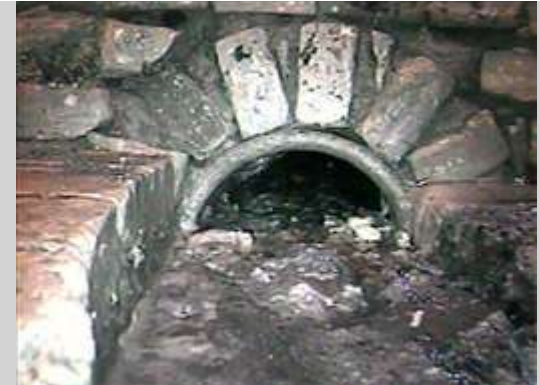
12 O'Clock Outflow

8 in. Circular Gravity Sewer
Pipe Out @ 12 O'Clock

Deposits: ☐ None ☐ Mud ☒ **Sludge** ☒ **Debris** ☒ **Grease**

Silt Depth: **5** (in.) Deposits Extent: **Heavy**

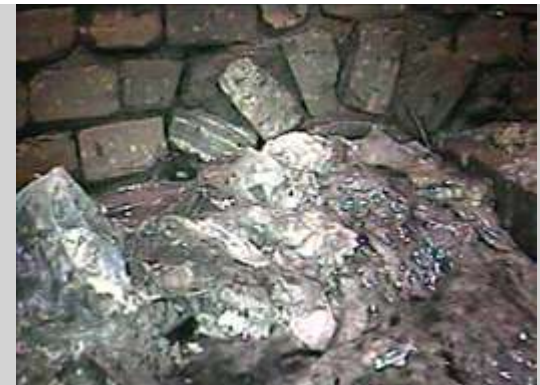
3 O'Clock Inflow

8 in. Circular Gravity Sewer
Pipe In @ 3 O'Clock

Deposits: ☐ None ☐ Mud ☒ **Sludge** ☒ **Debris** ☒ **Grease**

Silt Depth: **7** (in.) Deposits Extent: **Heavy**
